ET Door Drive Actuator Anomalies & Repair Plan

**Jeff Goodmark
Boeing Mechanical Systems SSM**

**OPO Technical Tagup
06/18/08**

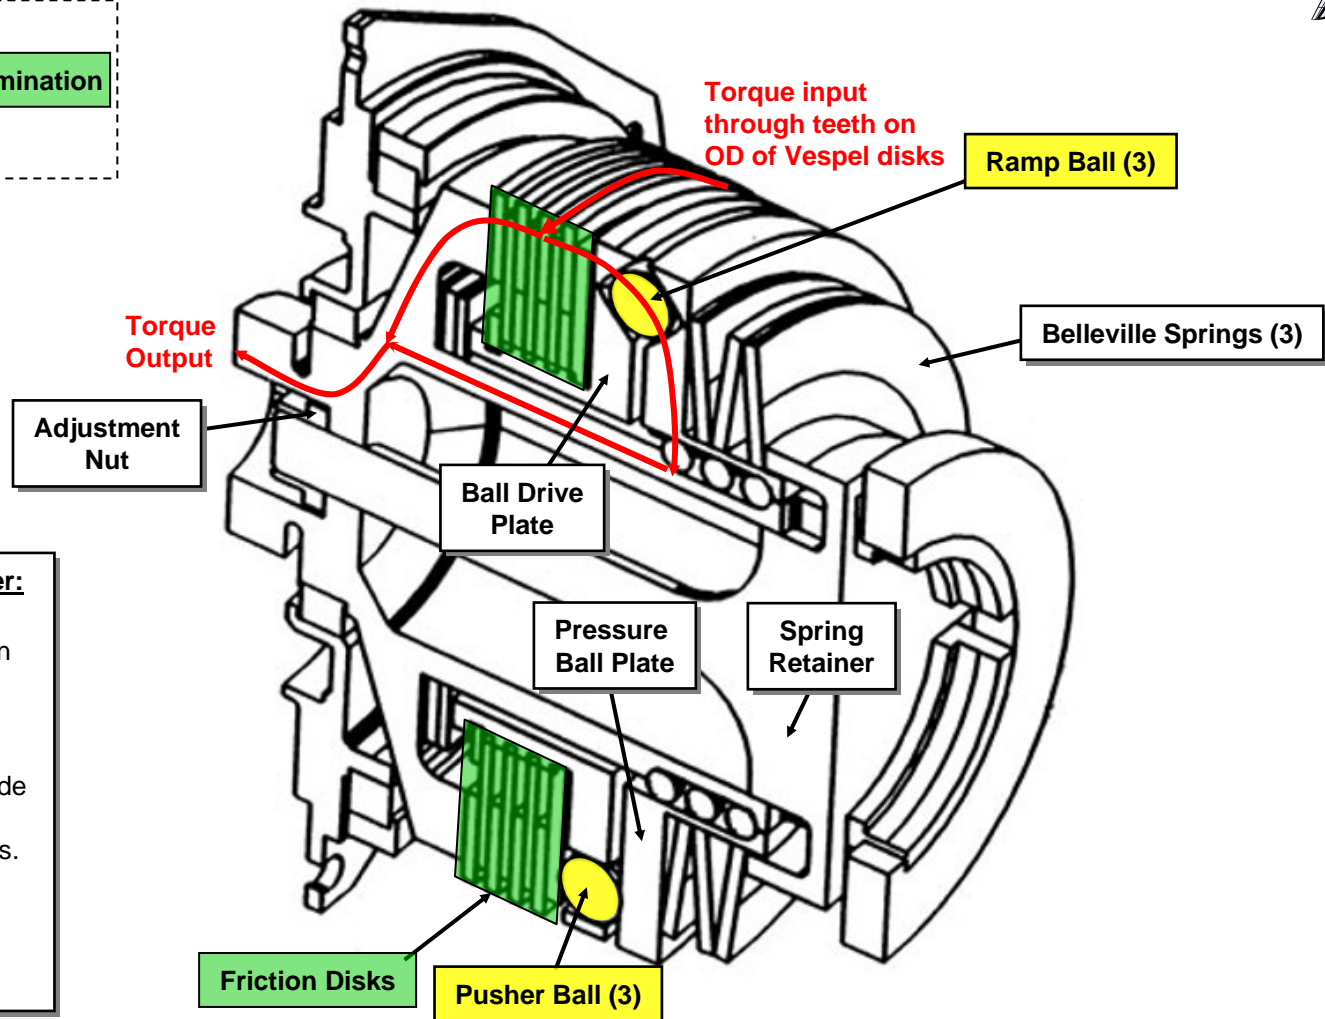
Torque Limiter Diagram

- Torque limiter degradation
 - Discovered in 2002
 - Caused by Braycote grease contamination on friction disks during assembly
 - Time-related (slow migration of oil onto disk surfaces)

- Caused by mislabeled packaging at ball supplier
 - Present in qual unit and all flight units
 - Accepted as-is due to nominal actuator performance
 - MRD required for each repaired actuator prior to shipment from Telair

Discrepancies:

Braycote Grease Contamination

Undersized

- On-vehicle trending implemented every flow with ET Door push test
 - Remedied by disassembly & thorough cleaning of torque limiter components
- Motor clutch/brake disk wear

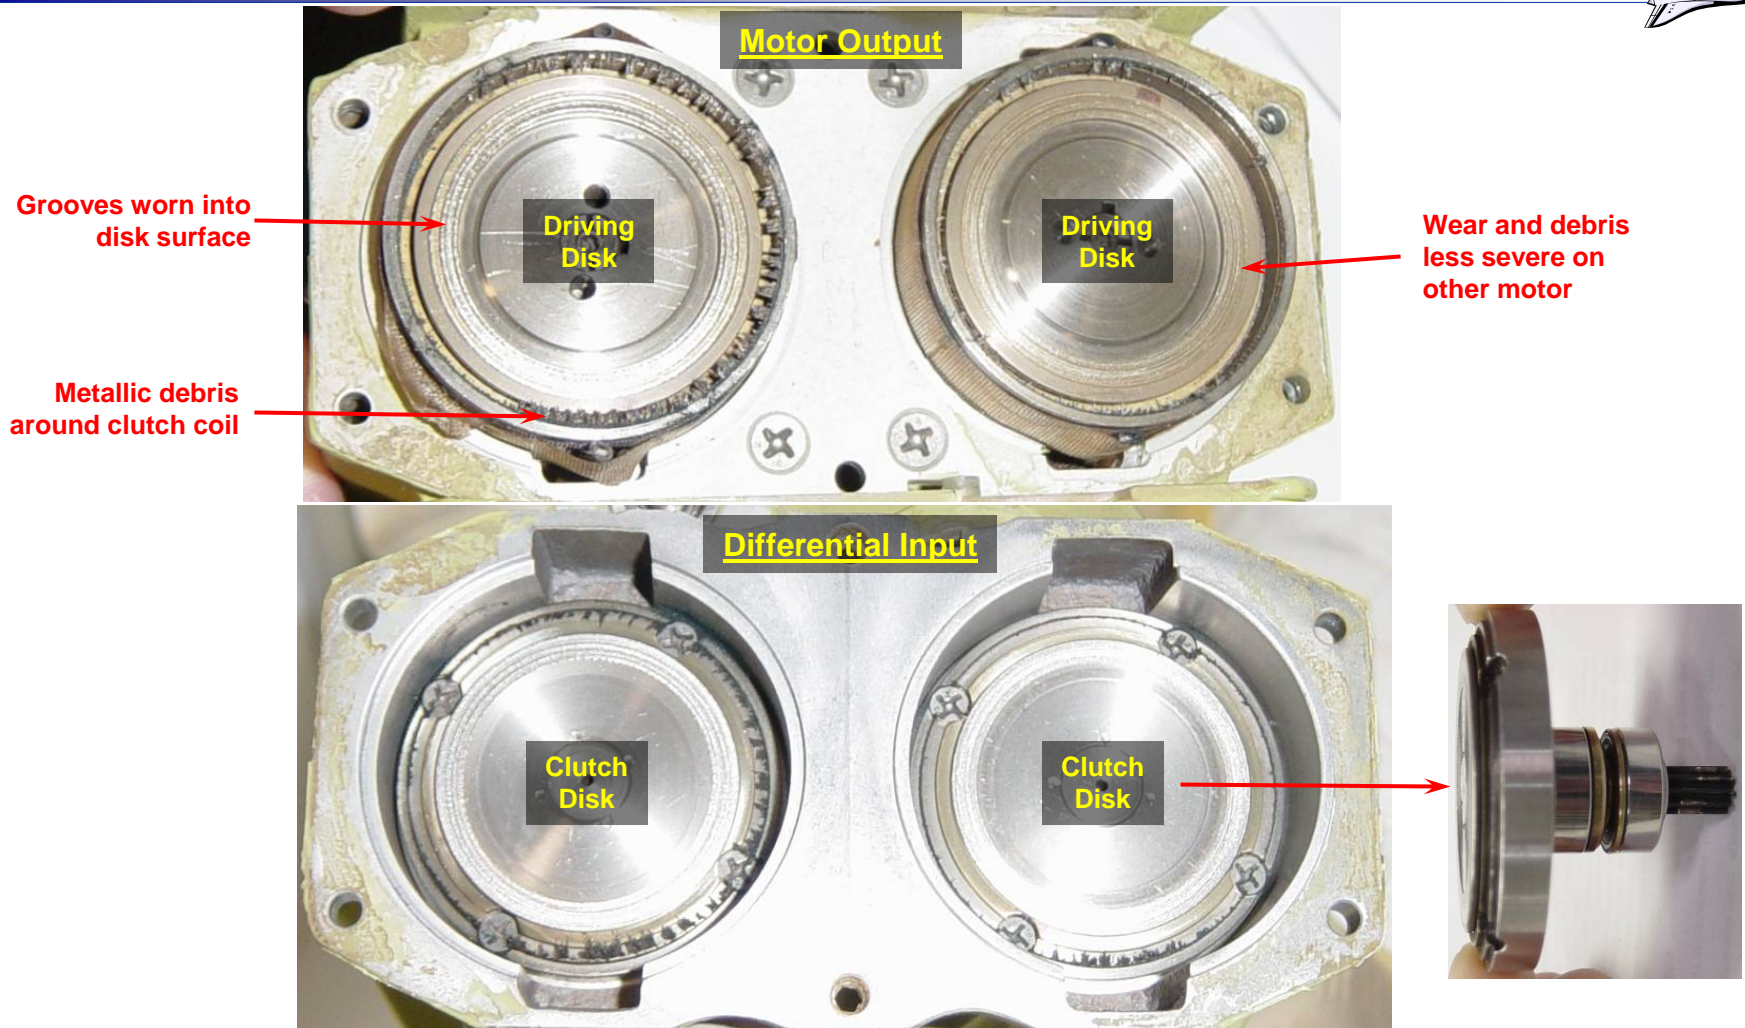
- Discovered in 2006 during push testing for item 1
 - Results in premature slippage of clutch and/or brake disks
 - Root cause unknown
 - Cycle-related, but observed trend is not linear

Example of Clutch Disk Wear (TU114)

- Remedied by replacing clutch/brake assemblies with new spares
- Undersized torque limiter pusher & ramp balls
 - Discovered in 2002 during failure analysis for item 1

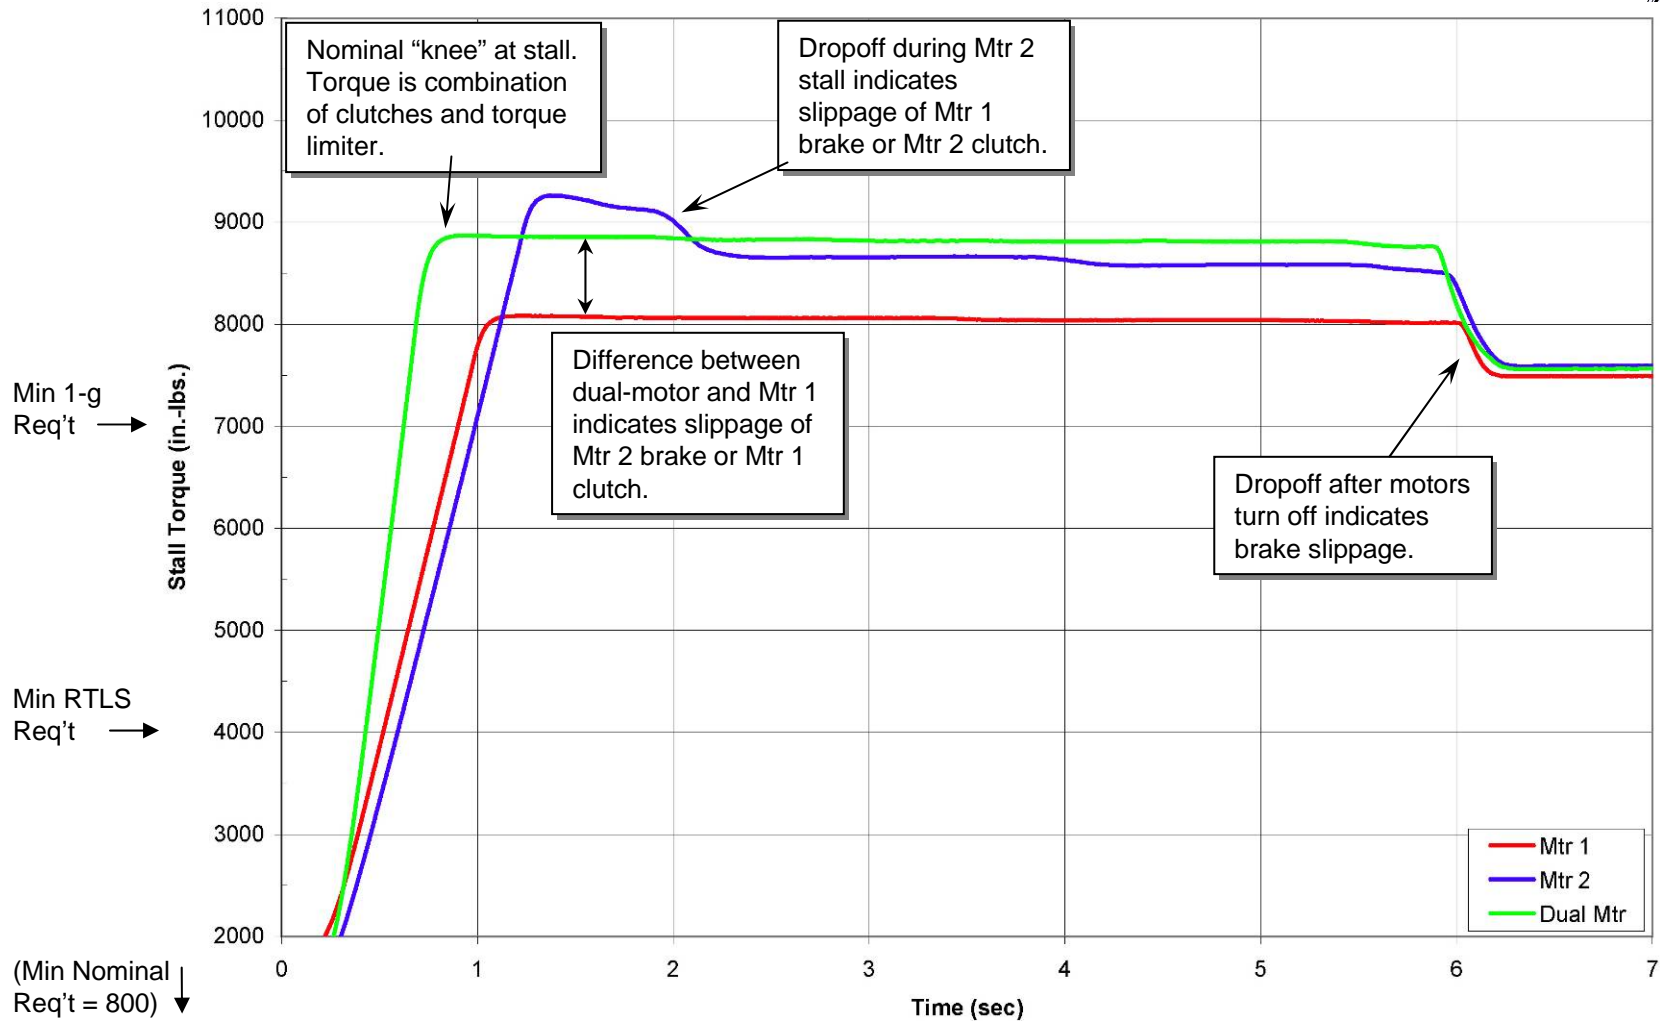
TU102 Push Test Results

(OV-104 RH, 4/09/08)

- ET Door Drive Actuators should be cycled through the vendor/NSLD for repair of all three discrepant conditions
 - Trending results show continual degradation in stall torque
 - Rate varies between units and is not necessarily linear
 - Risk of failing functional test & requiring actuator R&R late in the flow
- TU101 R&R (OV-105 RH) should be scheduled during current flow
 - Most overall degradation since last ATP
 - Second-lowest overall stall torque
 - Second-highest degradation rate
 - Spare actuator (TU114) delivery estimated for late July or early August
- Once TU101 is repaired, candidates for next R&R should be:
 - TU102 (OV-104 RH)
 - TU112 (OV-103 RH)
 - TU115 (OV-105 LH)

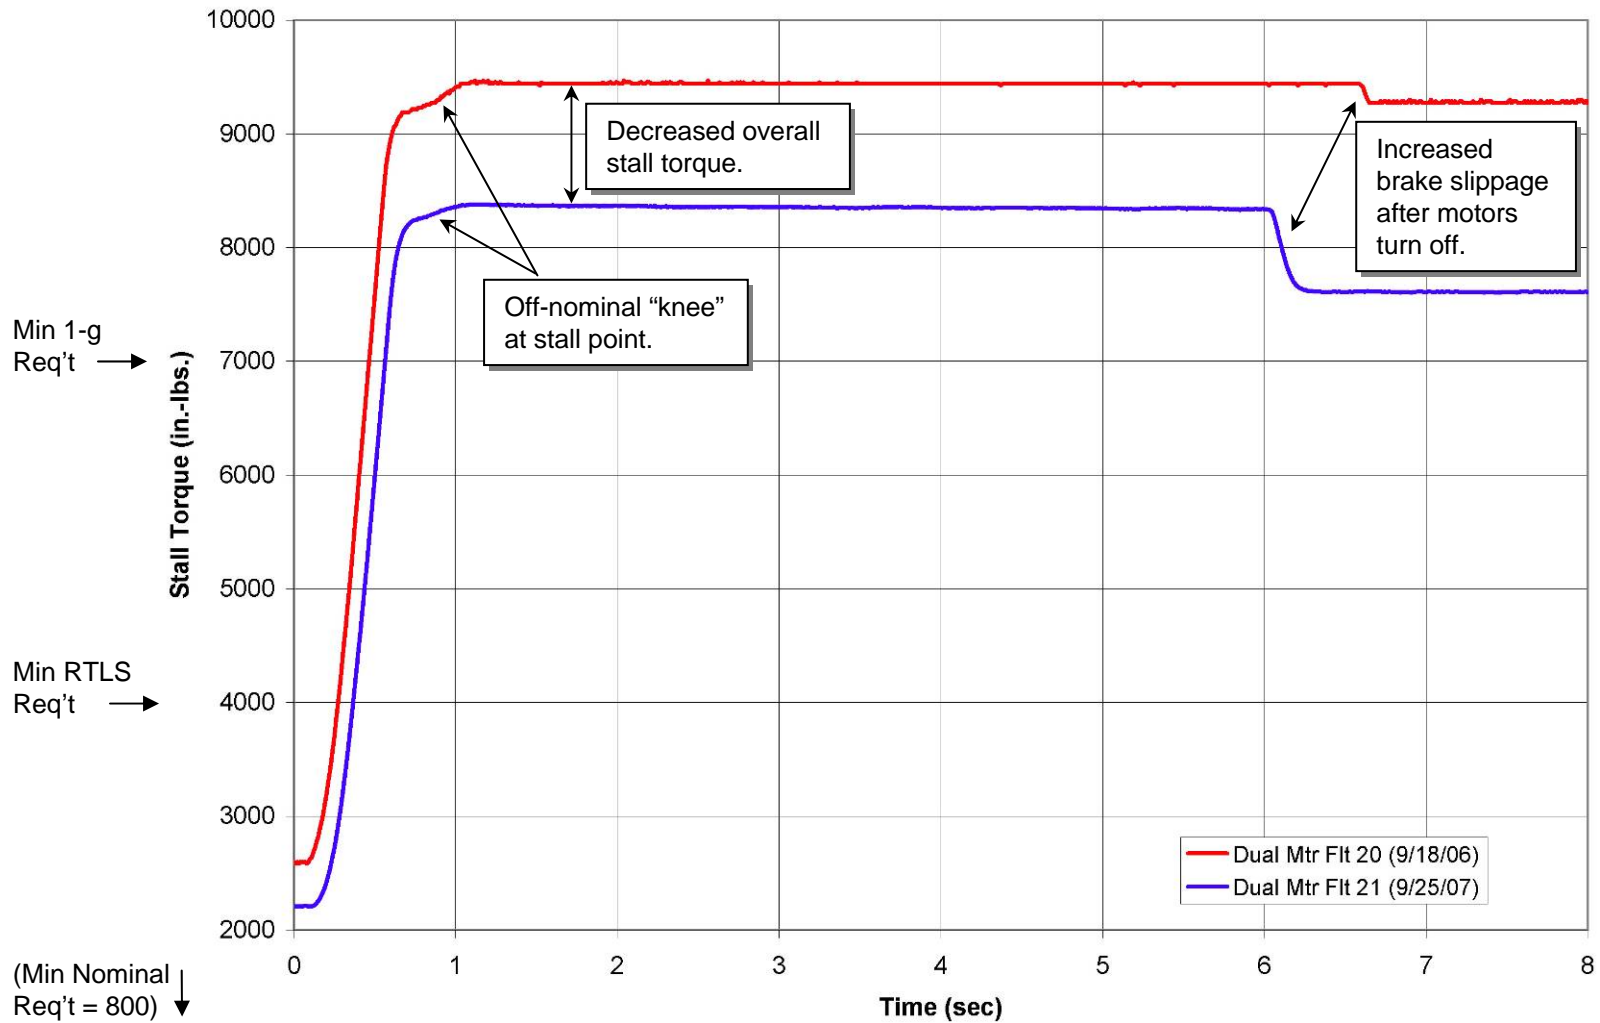
TU101 Push Test Results

(OV-105 RH, Dual Motor, Flts 20 & 21)

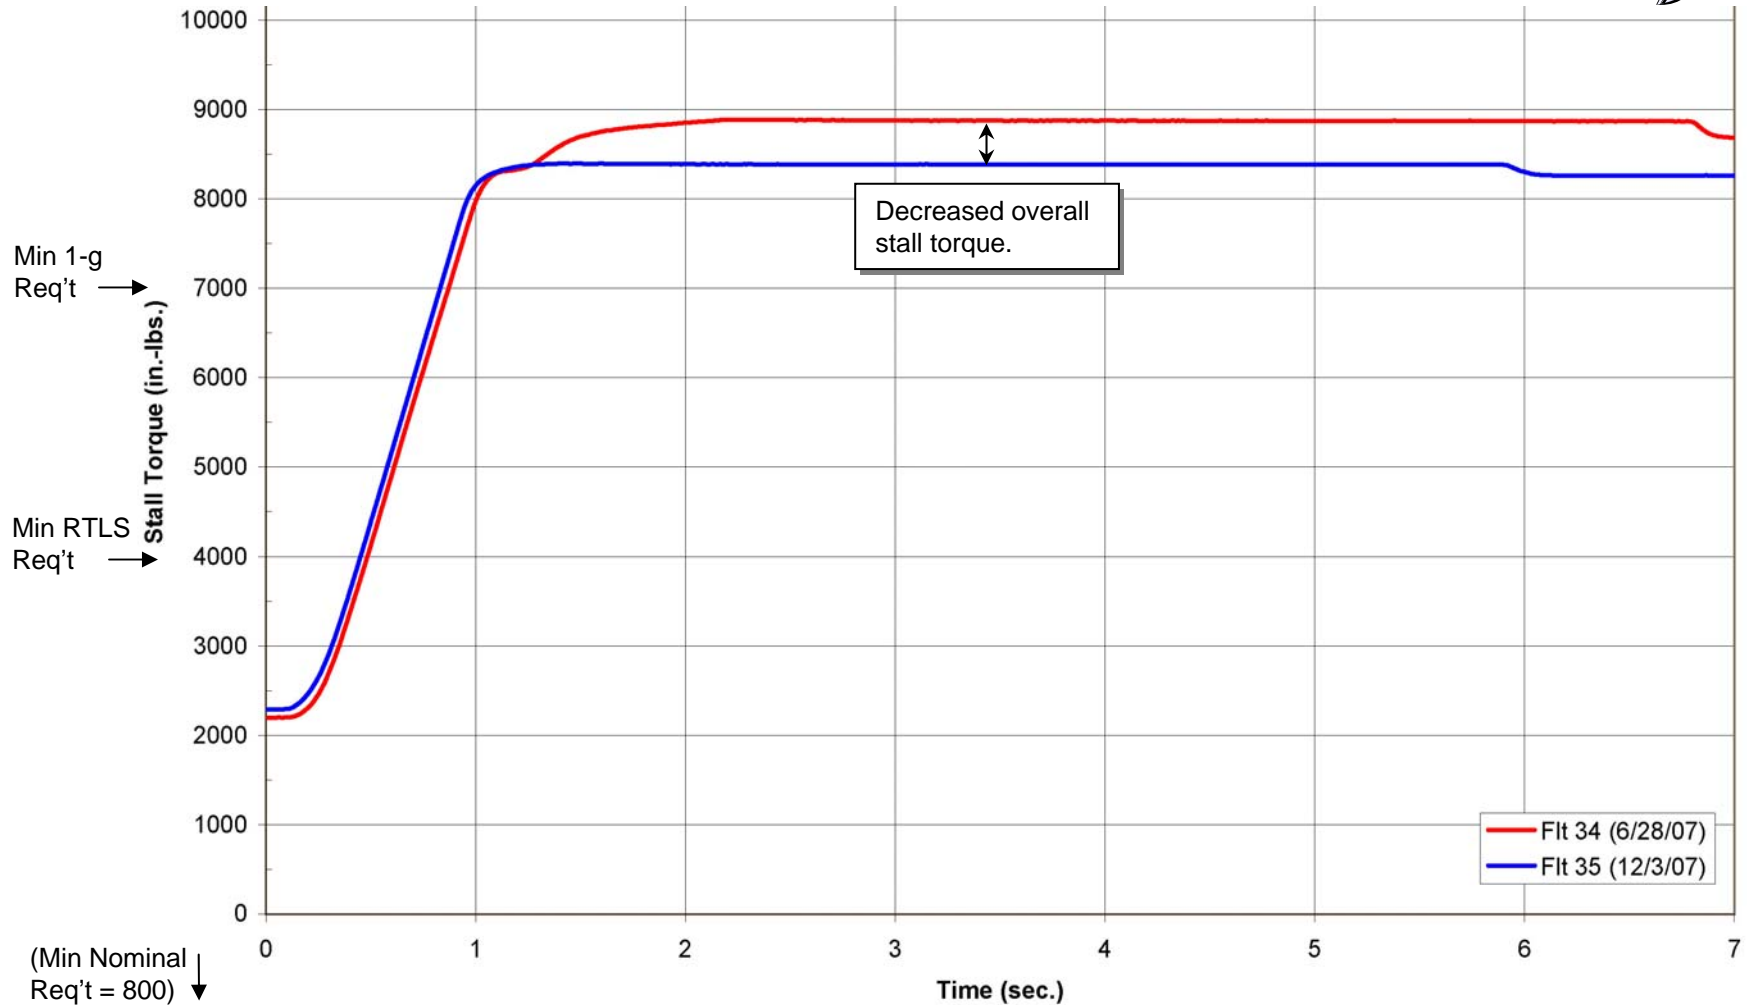
TU112 Push Test Results

(OV-103 RH, Motor 2, Flts 34 & 35)

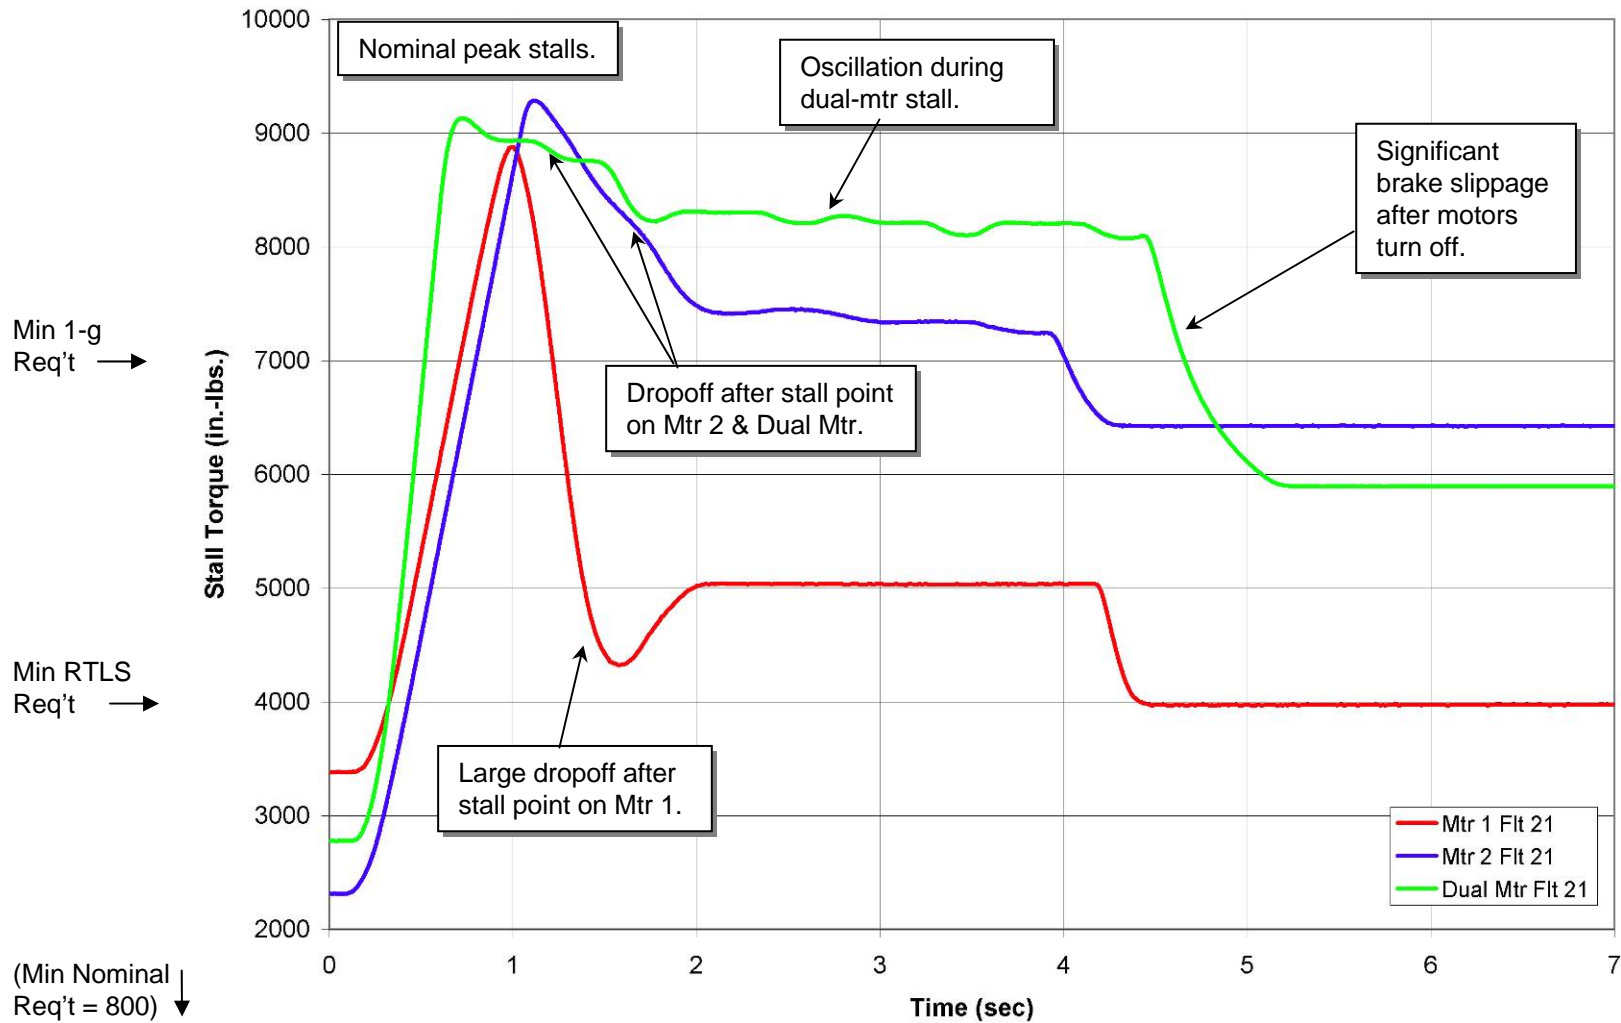
TU115 Push Test Results

(OV-105 LH, 9/24/07)
